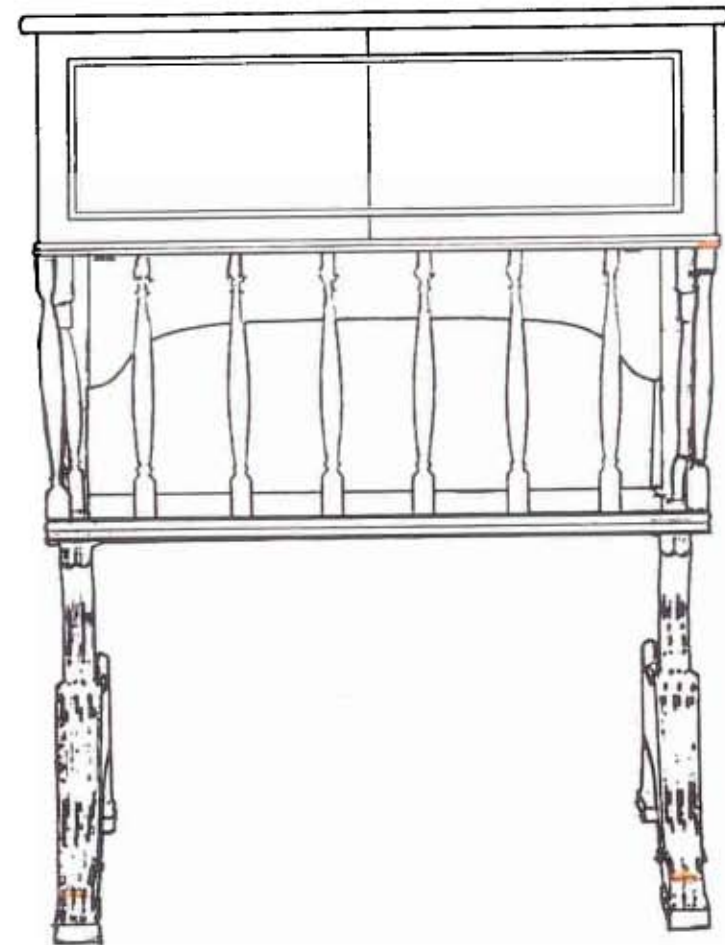
Rear View

Note
book-matched
veneer

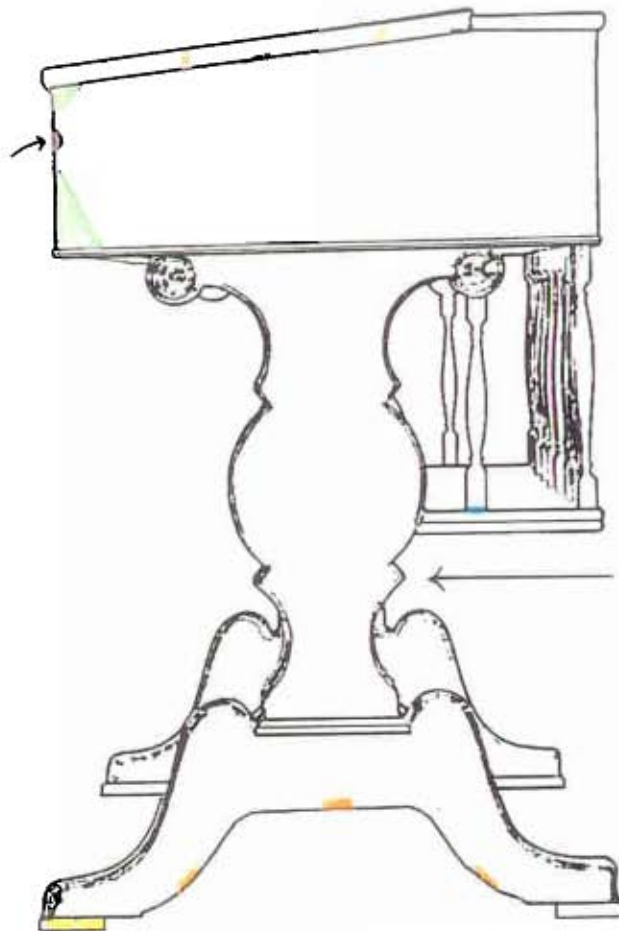
Right Side

*Note: No cross-banding
on pedestal legs*
